LLNL-TR-661706

Summary of DKDP boule fracture tests

SUBJECT: Summary of DKDP boule fracture tests

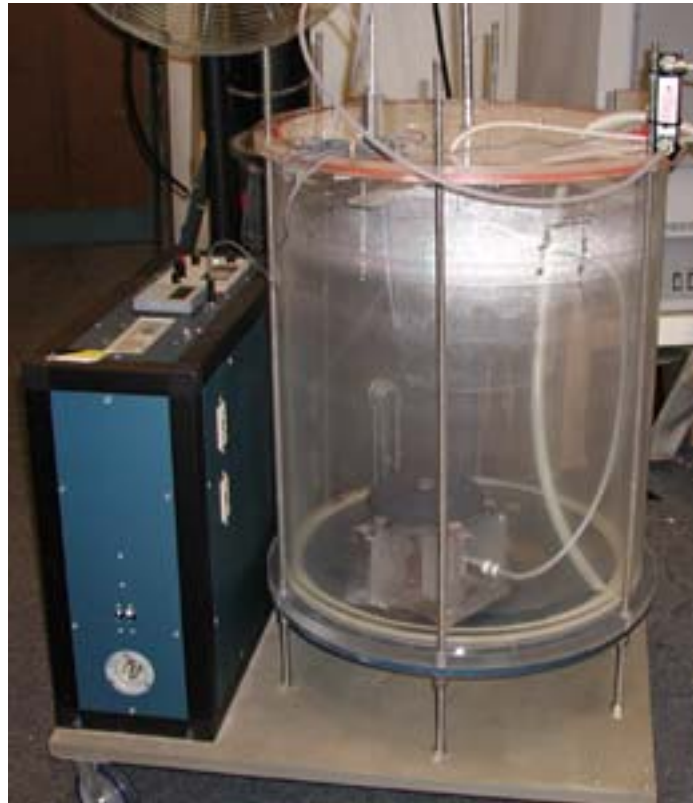
Figure 1. (a) Photograph of sparger; (b) schematic of setup used for the thermal shock experiments. The numbers represent the locations of the thermocouples: (1) bottom of crystal, (2) platform arm, (3) platform shaft, (4) head space, and (5) bath temperature.

A temperature-controlled sparger (in which air is bubbled through bubbler in a temperature controlled water bath to saturate the air) was fabricated in order to provide the water-saturated, temperature-matched air into growth tank as the solution is removed [2,3]. A photograph of one of the spargers is shown in Fig. 1a. A series of thermocouples were placed in the growth tank to monitor the temperature of the crystal during cooling. The locations of the thermocouples are shown in Fig 1b, which shows a schematic of the setup.

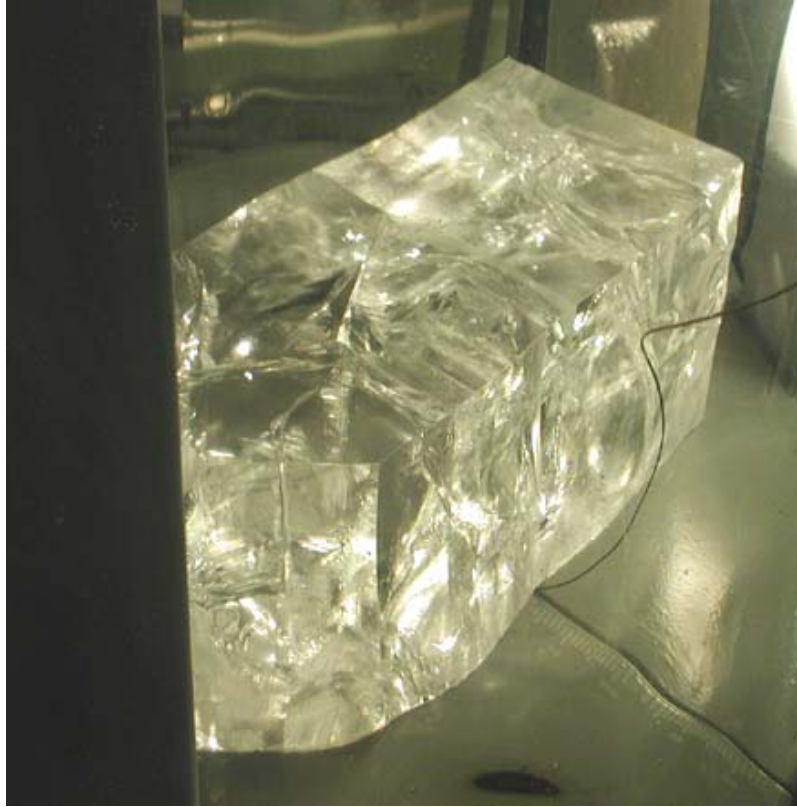
Figure 3. Photograph of $\frac{1}{2}$ FD-16 after cooling the crystal at a programmed rate of $200^{\circ}\text{C}/\text{day}$. $\Delta T = 7.3^{\circ}\text{C}$.

A summary of the tests performed on the large size crystal boules are shown in Table 1. A detailed account of experimental for each of the individual tests can be found in the crystal growth notebook [4], and hence is only briefly described here. In the first four tests, ½ of crystal FD-16 (a horizontal grown crystal, 85 kg) was placed in the growth tank and heated to ~60°C in air. The water bath was then programmed to cool at 15, 30, 100, and 200°C/day. The measured temperatures at the various locations are plotted as a function time in each for each of these tests in Fig. 2. The crystal fractured after cooling at 200°C/day (see Fig. 3).
